Cleaning Coupons – TOSI and Steris Verify All Clean

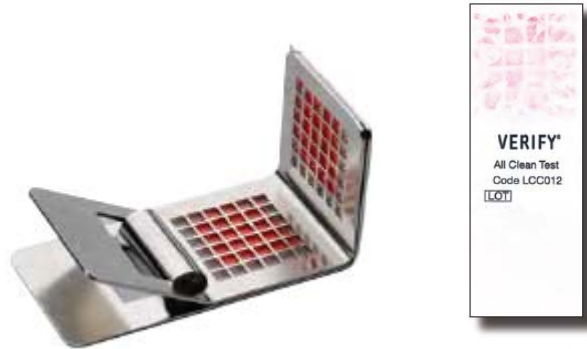
The Steris cleaning coupon has two surfaces, a vertical surface and a horizontal surface. The vertical surface is used to check for wash spray impingement (force) while the horizontal is an indication of sufficient fluid flow.

In washers that are designed with a forceful downward spray (impingement) from the arm, this test coupon may be appropriate.

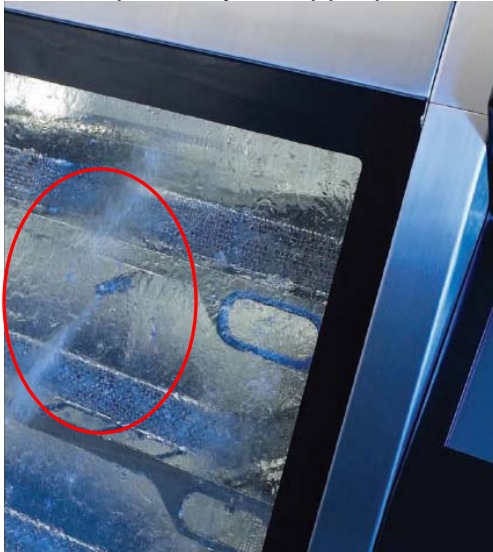
Impingement Related Failure

As indicated by the coupon on the right, the vertical surface is not completely clean, indicating an impingement failure (not enough spray pressure).

These coupons are essentially designed for Steris washers which have a high impingement angled spray pattern as shown on the left.

The impingement spray will impact the vertical surface of the coupon directly, cleaning it.

Belimed washers are designed with a low impingement, high flow volume approach and, with the WD250, the low pressure (low impingement) spray is up, not down. While Belimed is confident that the Steris coupons will be cleaned they are not the appropriate choice for the wash arm approach used in the Belimed washers and a may create a false positive with the vertical surface.
